BRIDGE RE-EVALUATION SURVEY REPORT

**STRUCTURE NO. 0202-159
ROUTES US 1, 9 & 46 OVER JONES ROAD
BOROUGH OF FORT LEE
BERGEN COUNTY**

15TH CYCLE

JULY 15, 2008

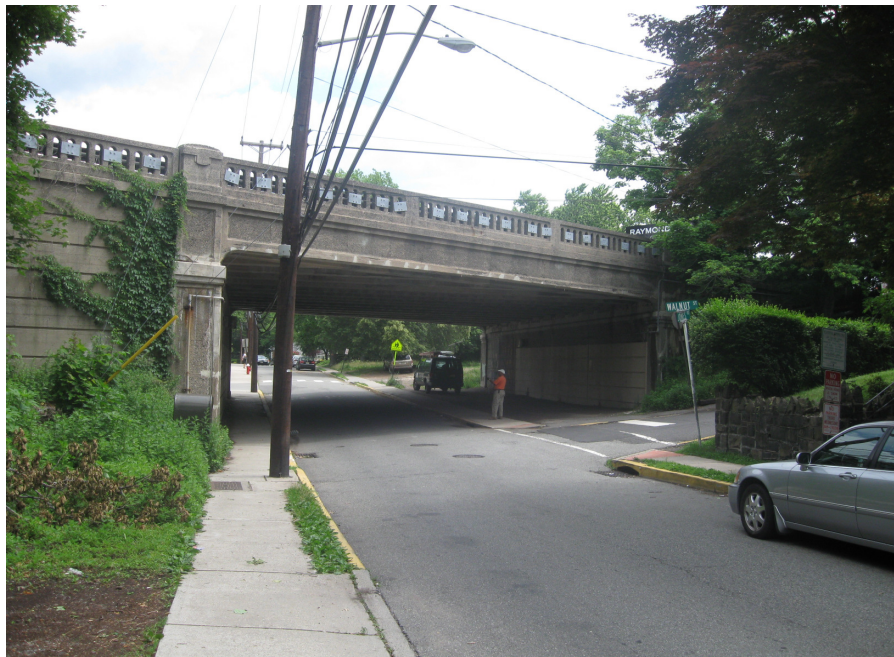
Photo No: 15-01

Location:	East elevation, looking West.
Description:	General view. Note: Structure fascia not posted for minimum vertical underclearance (typical west fascia).

*Posting for Load / Speed / Clearance Restrictions (Include a photo)	None. Minimum vertical underclearance 14'-3" and 14'-5" noted under west fascia (See Photo No. 15-01, underclearance sketch and attached Priority Repair Letter dated 7/30/2004).
----------------------------------------------------------------------	-----------------------------------------------------------------------------------------------------------------------------------------------------------------------------------

| 1. Post bridge for minimum vertical underclearance in accordance with NJDOT requirement for vertical clearance 14'-6". (Photo No. 15-01 and see attached Priority 1 Repair Letter dated July 30, 2004). | 1 Crew Day |

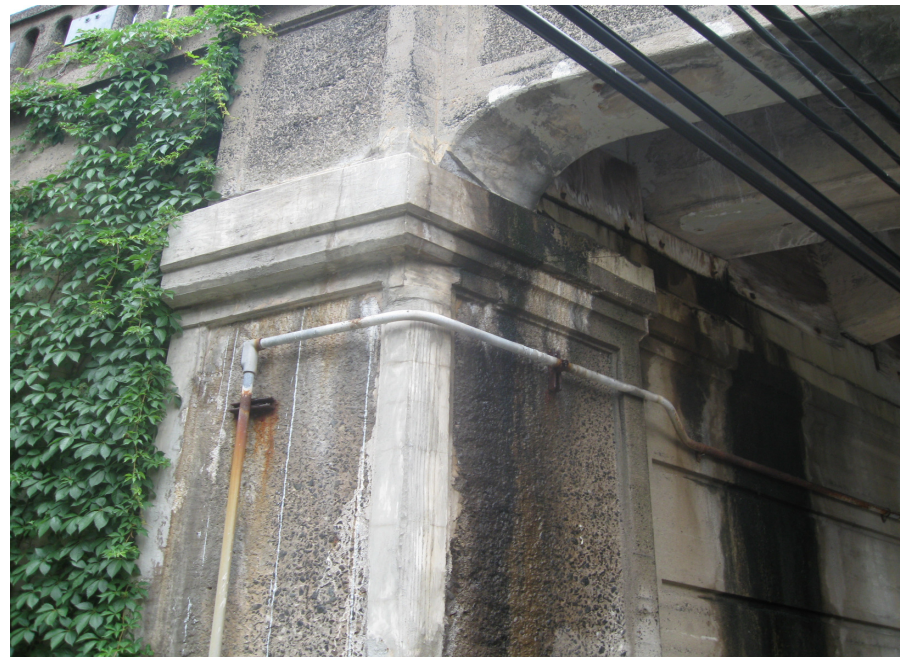
Photo No: 15-04

WORK DONE: Large spalled/deteriorated area of south abutment corbel, east end, has been repaired with concrete ([Photo No. 15-04](#)).

Location:	South abutment corbel, east end, looking South.
------------------	-------------------------------------------------

Description:	Work Done: Large spalled and deteriorated area has been repaired with concrete.
---------------------	---------------------------------------------------------------------------------

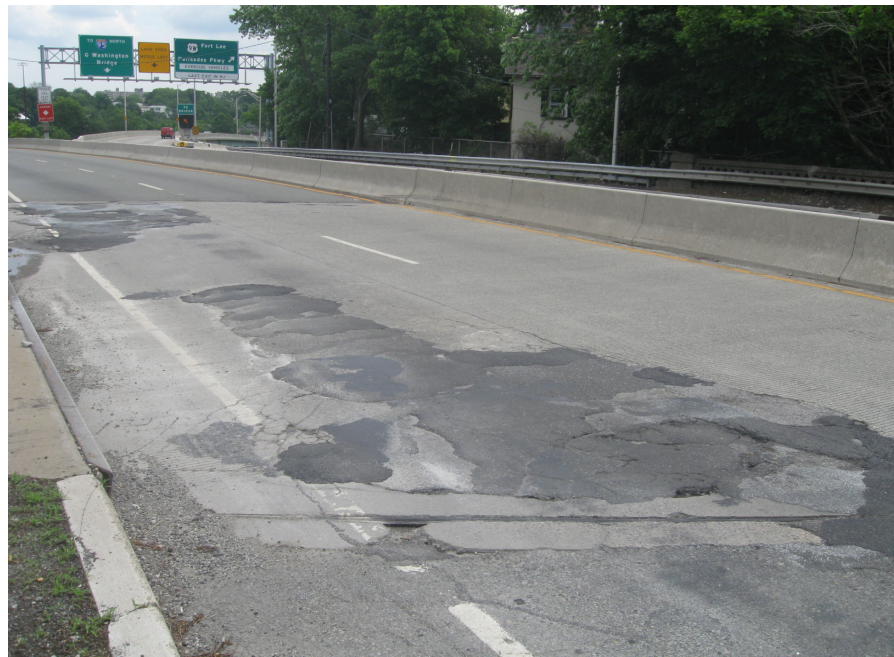
Photo No: 15-05

The deck is in poor condition due to several large areas of deteriorated/spalled concrete deck surface and uneven roadway surface from poor asphalt patching. The underside of deck exhibits a few areas of small and large incipient spalls ([Photo Nos. 15-05 through 15-08](#) and see attached Priority Repair Letters dated 7/26/2006 and 7/21/2008).

Location:	Southbound roadway, near south abutment, looking Northeast.
Description:	Loose area of delaminated LMC overlay and underlying concrete deck, repaired poorly with bituminous concrete.

| 2. Remove all delaminated LMC overlay and deteriorated concrete from deck, clean any exposed reinforcing steel and repair with epoxy concrete (Photo Nos. 15-05, 15-06 and see attached Emergency/Priority 1 Repair Letter dated July 21, 2008 and NJDOT Memorandum dated July 22, 2008). | 2 Crew Days |

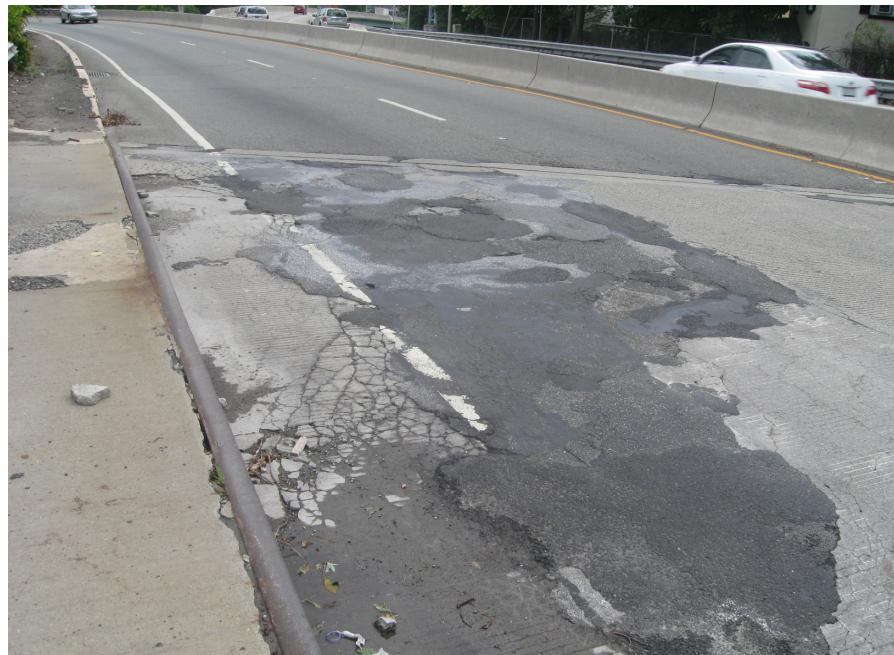
Photo No: 15-06

Location:	Southbound roadway, near north abutment, looking Northeast.
Description:	Loose area of delaminated LMC overlay and underlying concrete deck, repaired poorly with bituminous concrete.

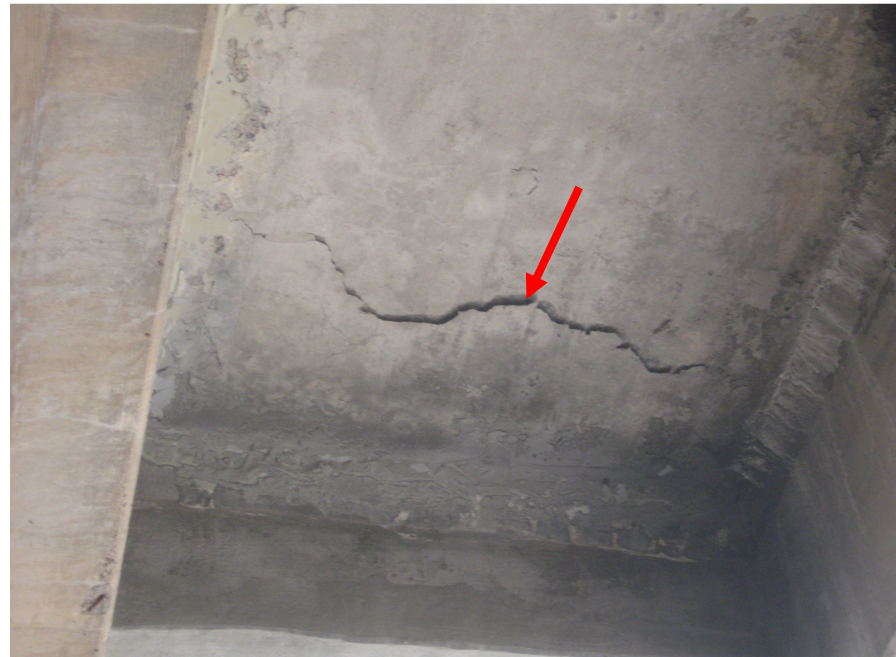
Photo No: 15-07

Location:	Underside of deck over eastbound lane of Jones Road, near south abutment, looking North.
------------------	------------------------------------------------------------------------------------------

Description:	Large area of incipient spall between stringers S15 and S16.
---------------------	--------------------------------------------------------------

| 3. Remove all incipient spalls from underside of deck (Photo Nos. 15-07, 15-08 and see attached Priority 1 Repair Letter dated July 21, 2008 and NJDOT Memorandums dated July 22, 2008 and July 31, 2006). | 1 Crew Day |

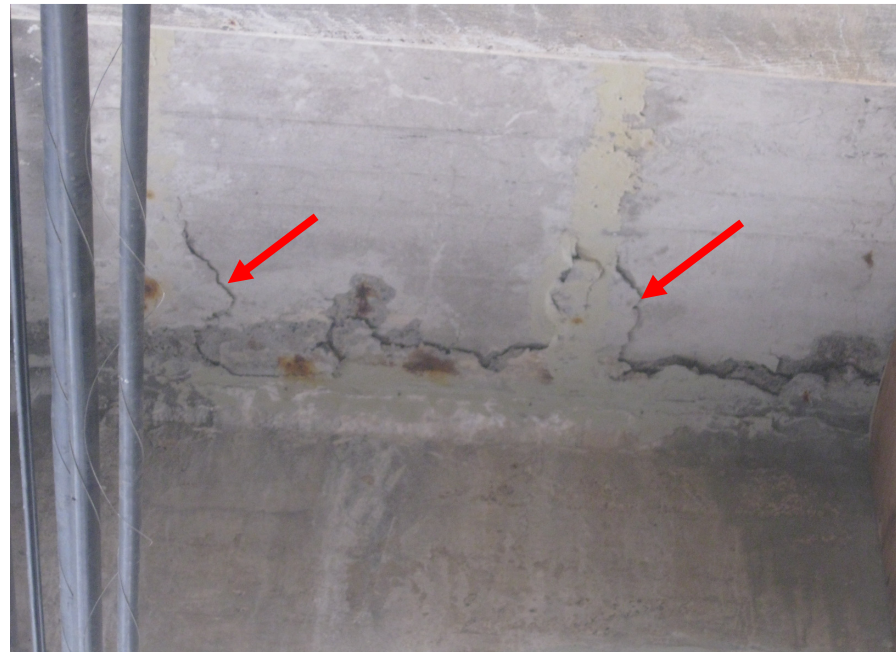
Photo No: 15-08

Location:	Underside of deck over Jones Road, south sidewalk, near south abutment, looking East.
------------------	---------------------------------------------------------------------------------------

Description:	Large area of incipient spall between stringers S15 and S16.
---------------------	--------------------------------------------------------------
